CENTRAL INTELLIGENCE AGENCY  
INFORMATION REPORT

COUNTRY Poland  
SUBJECT Port Information: Gdansk

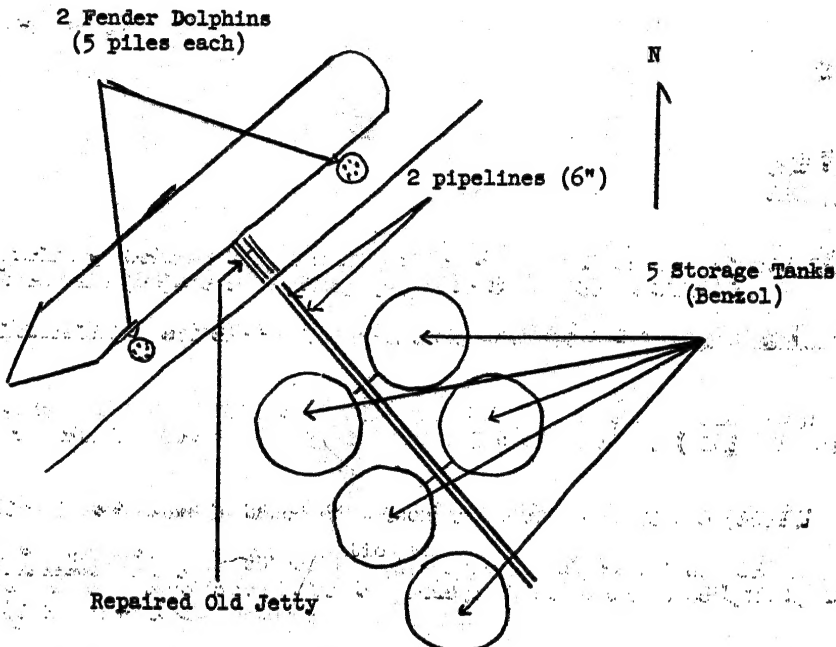
8. Berth Vessel berthed at benzol loading wharf at designator B. Wharf was an old Jetty that has been recently repaired, and two new fender dolphins of five piles each have been sunk into the channel to facilitate berthing. Wharf arrangement and tank storage area layout is drawn below:

10. Cargo Operations Vessel pumped ballast before boarding inspection, cleaned tanks after inspection was completed, received clearance to load at 082000A [ ] [ ] and commenced loading cargo immediately from two 6" pipelines leading from five benzol storage tanks. Vessel loaded 2557 metric tons benzol at a rate of approximately 200 tons per hour, and completed operation at 091100A [ ] [ ]. Four or five line operators were on duty on the wharf and aboard ship during the loading operation.
